DEPARTMENT OF TRANSPORTATION**DIVISION OF ENGINEERING SERVICES**

Contract #: 04-0120F4Cty: SF/ALA Rte: 80 PM: 13.2/13.9File #: 1.28**WELDING INSPECTION REPORT****Resident Engineer:** Casey, William**Address:** 333 Burma Road**City:** Oakland, CA 94607**Report No:** WIR-029005**Date Inspected:** 17-Jan-2013**Project Name:** SAS Superstructure**OSM Arrival Time:** 700**Prime Contractor:** American Bridge/Fluor Enterprises, a JV**OSM Departure Time:** 1730**Contractor:** American Bridge/Fluor Enterprises, a JV**Location:** Job Site**CWI Name:** William Sherwood**CWI Present:** Yes No**Inspected CWI report:** Yes No N/A**Rod Oven in Use:** Yes No N/A**Electrode to specification:** Yes No N/A**Weld Procedures Followed:** Yes No N/A**Qualified Welders:** Yes No N/A**Verified Joint Fit-up:** Yes No N/A**Approved Drawings:** Yes No N/A**Approved WPS:** Yes No N/A**Delayed / Cancelled:** Yes No N/A**Bridge No:** 34-0006**Component:** SAS Tower**Summary of Items Observed:**

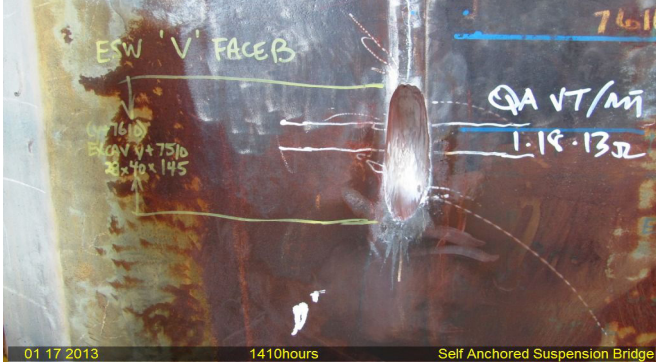
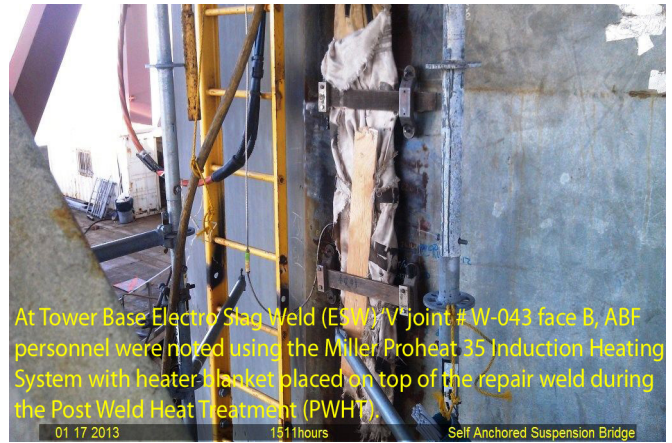
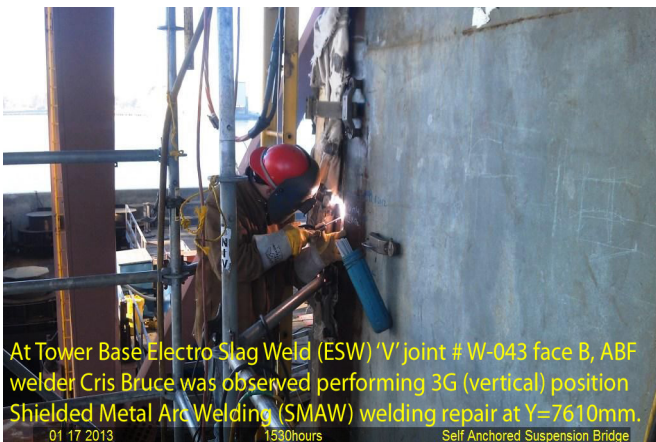
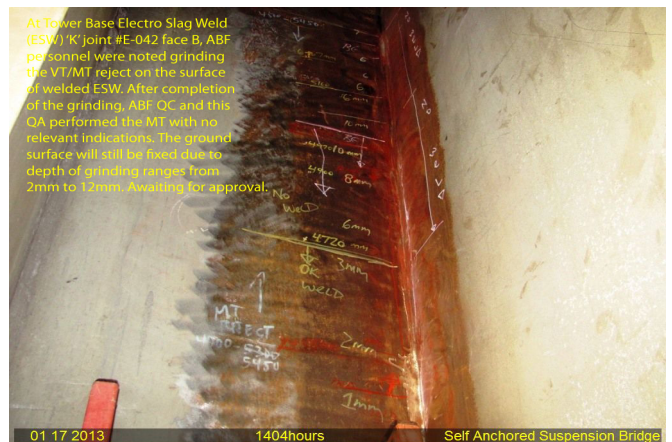
At the Tower Base, Electro Slag Weld (ESW) 'V' weld joint #W-043 face A, ABF welder Chris Bruce was observed performing the repair welding of the cover pass on previously welded ESW at Y=7610mm due to UT reject. The welder was noted utilizing Shielded Metal Arc Welding (SMAW) with 4mm diameter E7018H4R electrode implementing ABF-WPS-D15-1000 Repair Rev. 3. The welder excavated the defect using carbon air arc gouging followed by grinding the excavation to a bright metal. Prior to the excavation, the welder was noted preheating the repair area and its vicinity to 350°F using Miller Proheat 35 Induction Heating System with the heating blanket placed on the outside. After the excavation, ABF QC Steve Jensen performed the Magnetic Particle Testing (MT) of the excavation with the following dimensions: 145mm long x 40mm wide x 28mm deep with no relevant indications noted. This QA performed the same test (MT) and found same result. This weld repair was performed per Request for Weld Repair (RWR) #201301-027. During the shift, ABF QC Steve Jensen was noted monitoring the welding parameters and workmanship of the repair welding. At the end of the shift, the repair welding mentioned above was still in progress at the end of the shift. Though the repair was incomplete, the welder still performed the Post Weld Heat Treatment (PWHT) of 350°F as required.

At Tower Base Electro Slag Weld (ESW) 'K' weld joint # E-042 face B, ABF personnel was noted grinding the surface of the weld cover due to VT/MT reject at the location Y=2500mm to Y=5450mm. After the completion of the grinding, ABF QC William Sherwood performed the Magnetic Particle Testing (MT) on the ground areas with

no relevant indications noted. This QA performed the same test (MT) and noted same result. The surface depth of the following Y locations were measured and noted;

1. Y=2500-Y=3250mm 1-2mm deep To be repaired/welded without RWR.
2. Y=3250-Y=3750mm <5mm deep To be repaired/welded without RWR.
3. Y=3750-Y=4100mm 10-12mm deep Awaiting for RWR prior repair/welding.
4. Y=4100-Y=4720mm <5mm deep To be repaired/welded without RWR.
5. Y=4720-Y=4900mm 6mm deep Awaiting for RWR prior repair/welding.
6. Y=4900-Y=4970mm 8mm deep Awaiting for RWR prior repair/welding.
7. Y=4970-Y=5160mm 10mm deep Awaiting for RWR prior repair/welding.
8. Y=5160-Y=5450mm 6-7mm deep Awaiting for RWR prior repair/welding.

At Tower Base Electro Slag Weld (ESW) 'V' joint # W-043 face B, the excavation profile of the repair was measured 145mm long x 40mm wide x 28mm deep at location Y=7610mm.
